**SAS Superstructure**

Location: 04-SF-80-13.2 / 13.9

Daily Diary Report by Bid Item

**04-0120F4
04-SF-80-13.2/13.9
Self-Anchored
Suspension Bridge****Weather**

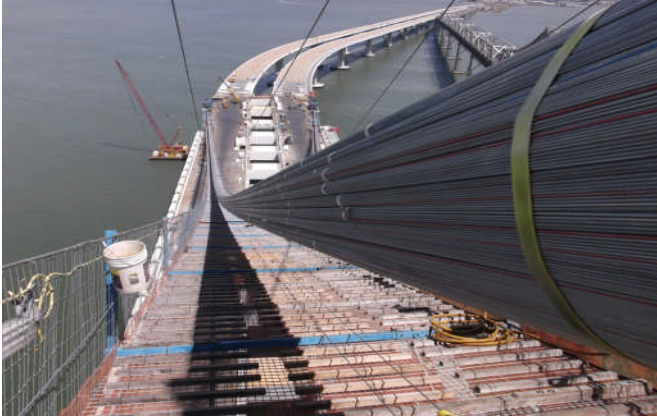
Good strand positions ahead of compactor - exterior strands

- Note: the shape of the Cable & the strands in the Cable bundle were positioned correctly ahead of the compactor (see attached photos).
- For the remainder of the shift, they continued compacting & banding while working down the span. They were only advancing forward about 0.9m per squeeze. The readings below were measurements taken by me on at the strap locations. They are after the load was released.

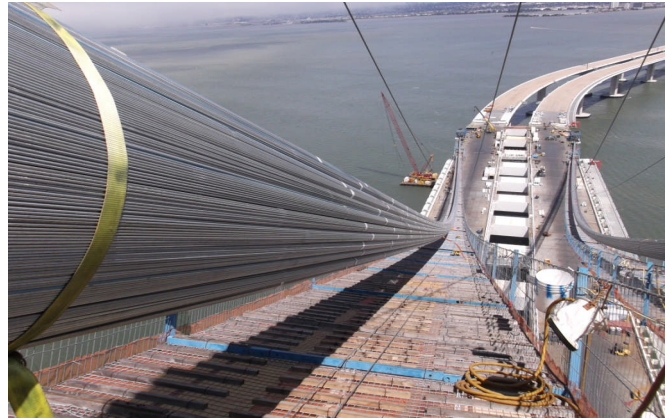
Good strand positions ahead of compactor - interior strands
